Manhole Inspection Summary

Manhole # S05AA2010MH

Insp Date: **9/20/06 11:02 AM**

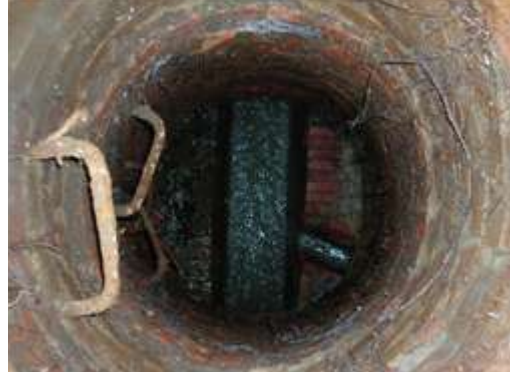
Top View

Corroded steps. Evidence of surcharge - Bench debris.

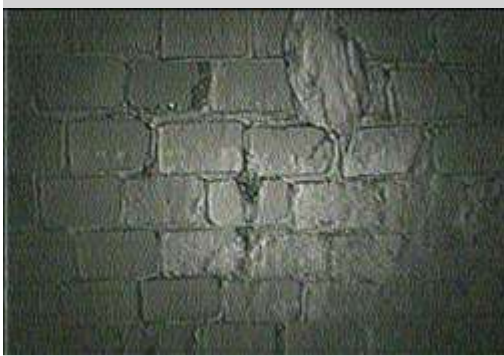
Defect

Barrel root intrusion and infiltration.

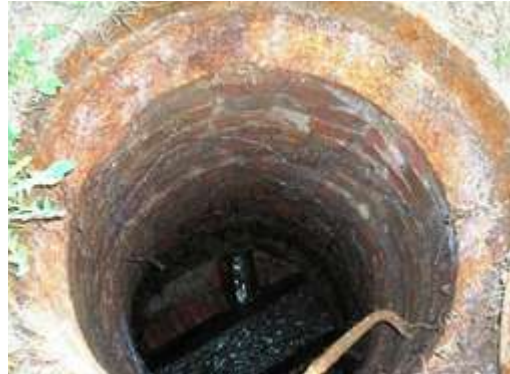
Defect

Frame leaks. Adjustment, Corbel and Barrel root intrusion and infiltration - other side.

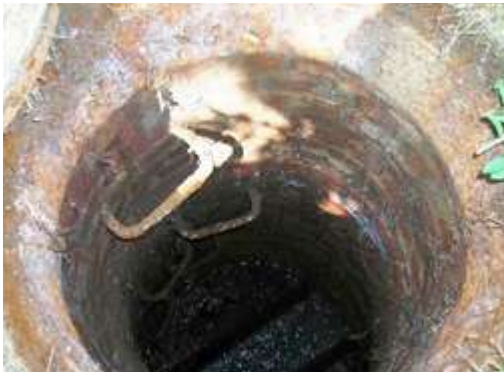
Defect

Frame leaks. Adjustment, Corbel and Barrel root intrusion and infiltration.

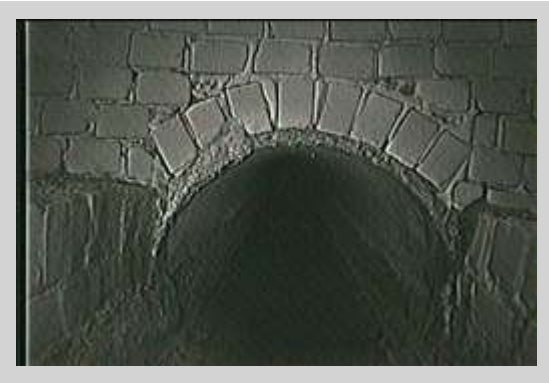
21 in. Circular Gravity Sewer Pipe Out @ 12 O'Clock

Infiltration: **Evidence** Pipe Seal Cond: **Unknown**

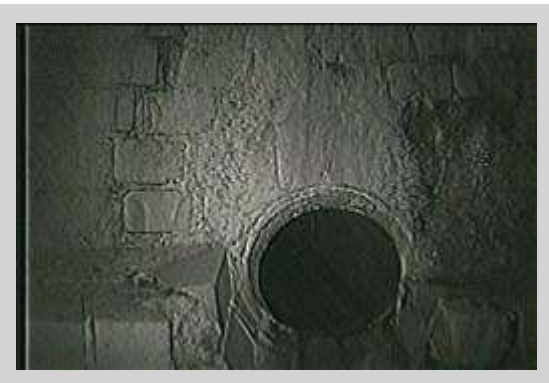
8 in. Circular Gravity Sewer Pipe In @ 4 O'Clock

Infiltration: **Evidence** Pipe Seal Cond: **Unknown**

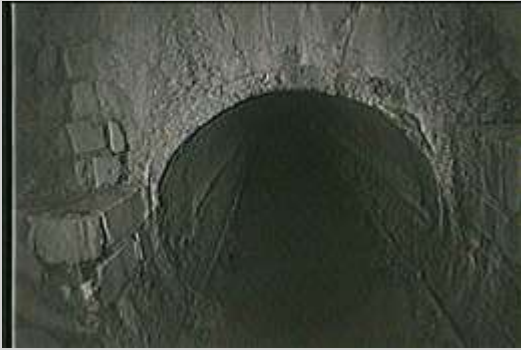
Pipe In @ 6 O'Clock

Barrel deterioration and infiltration. Channel deterioration.

Infiltration: **Evidence** Pipe Seal Cond: **Cracked**
